Manhole Inspection Summary

Manhole # S29CC1041MH

Insp Date: **12/15/06 9:46 AM**

Location Address: **37TH ST**

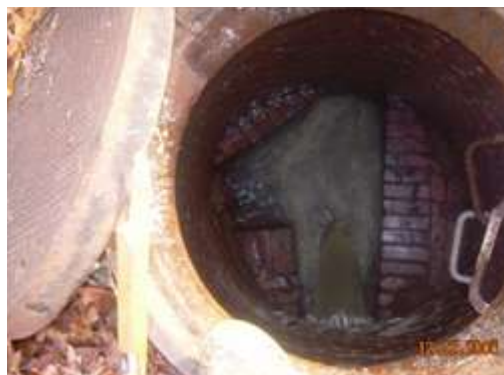
Top View

Infiltration: ☐ None ☒ **Joint** ☐ Cracks ☐ Mortar ☐ Roots ☒ **Wall**

☒ **Debris** (not Condition related)

☒ **Corroded**

Corbel infiltration. Corroded steps. Bench debris.

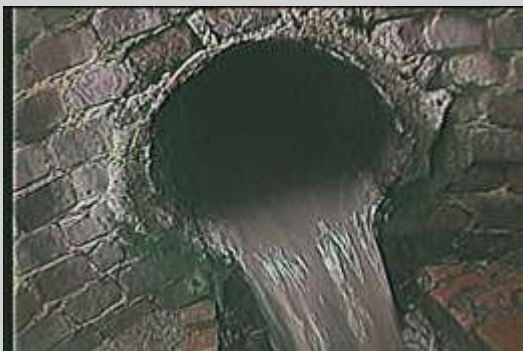
14 in. Circular Gravity Sewer Pipe In @ 6 O'Clock

Condition: ☐ Sound ☐ Cracked ☐ Root Intrusion ☐ Loose Brick ☒ **Deteriorated**

Infiltration: ☐ None ☐ Joint ☐ Cracks ☒ **Mortar** ☐ Roots ☐ Wall

Barrel deterioration and infiltration.

Infiltration: **Evidence** Pipe Seal Cond: **Unknown**

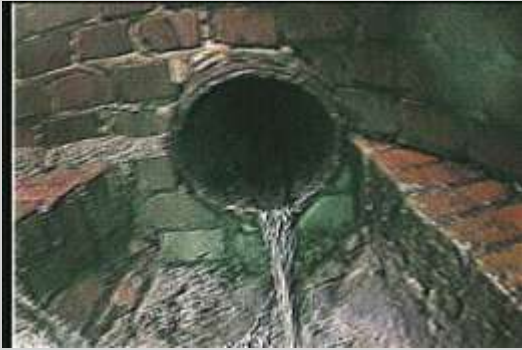
8 in. Circular Gravity Sewer

Condition: ☐ Sound ☐ Cracked ☐ Root Intrusion ☒ **Deteriorated** ☐ Leaks ☐ Debris

Channel deterioration.
